Stormwater Technical Information Report

Skokomish Recycle-Transfer
Skokomish, WA 98584
2240340.10

**Skokomish Indian Tribe - Recycle & Transfer
Building Replacement
80N Tribal Center
Skokomish, WA 98584
Parcel No. 42111-41-60010**

Subject: Geotechnical Engineering Report
Skokomish Indian Tribe - Recycle & Transfer Building Replacement
80N Tribal Center
Skokomish, WA 98584
Parcel No. 42111-41-60010

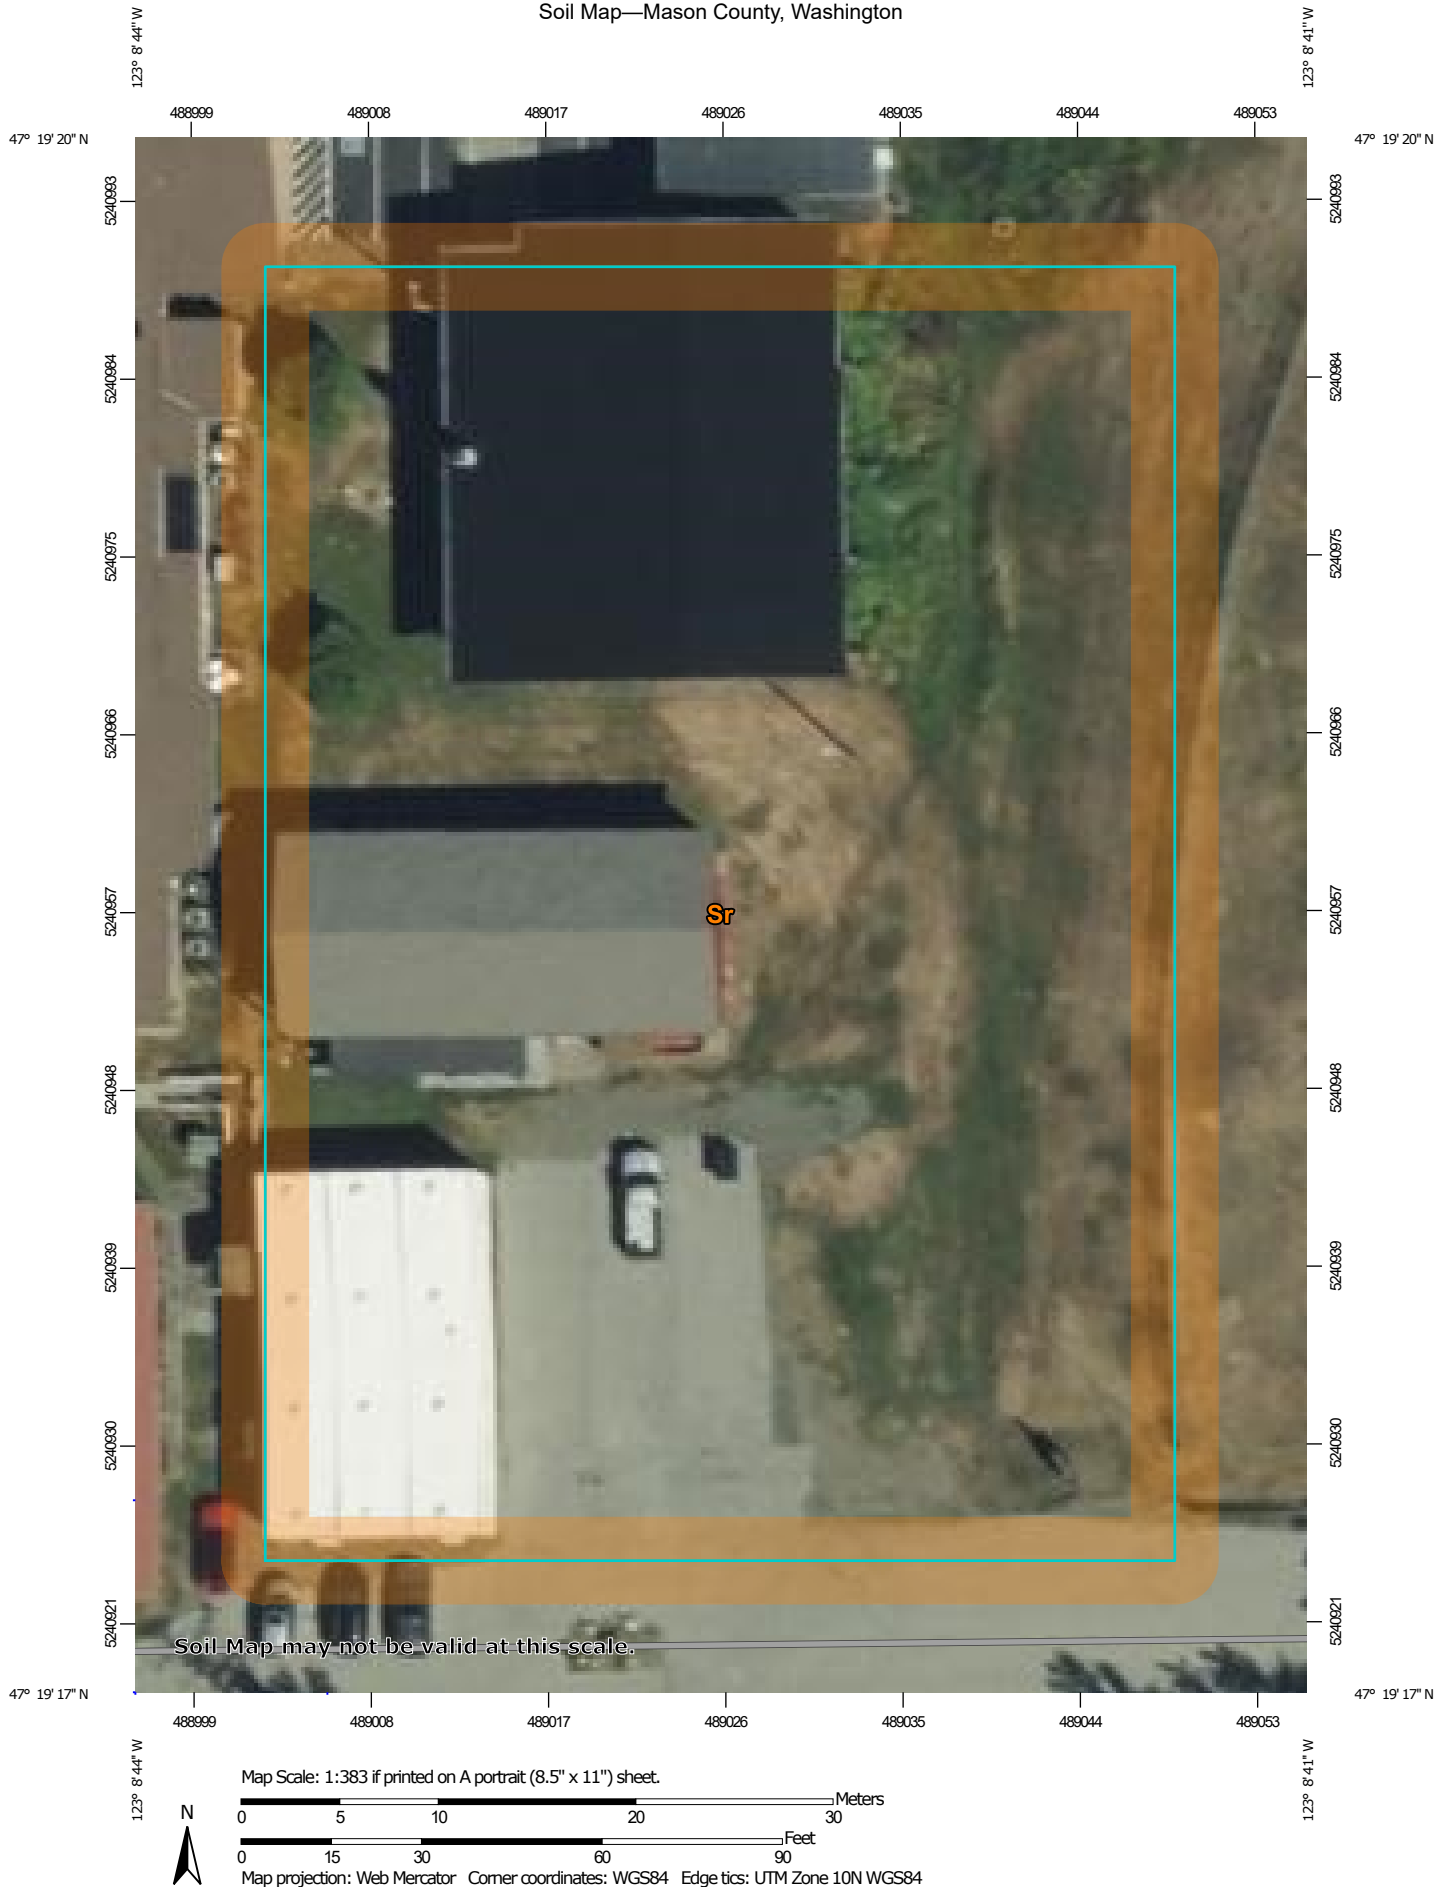
Soil Map—Mason County, Washington

The Natural Resources Conservation Service (NRCS) classifies the onsite soil as Skokomish silt loam. Skokomish silt loam is a hydric soil characterized as level, poorly drained, with high seasonal groundwater. An NRCS soil map and descriptions are included in Appendix A-4. Subsurface explorations by Migizi Group, Inc. identified native alluvial soils ranging from fine silty sand to gravel with fine to coarse sand. Groundwater was encountered in all test pits at 21 to 24 inches of depth, indicating that infiltration is not feasible. Refer to Appendix B for the Geotechnical Engineering Report.

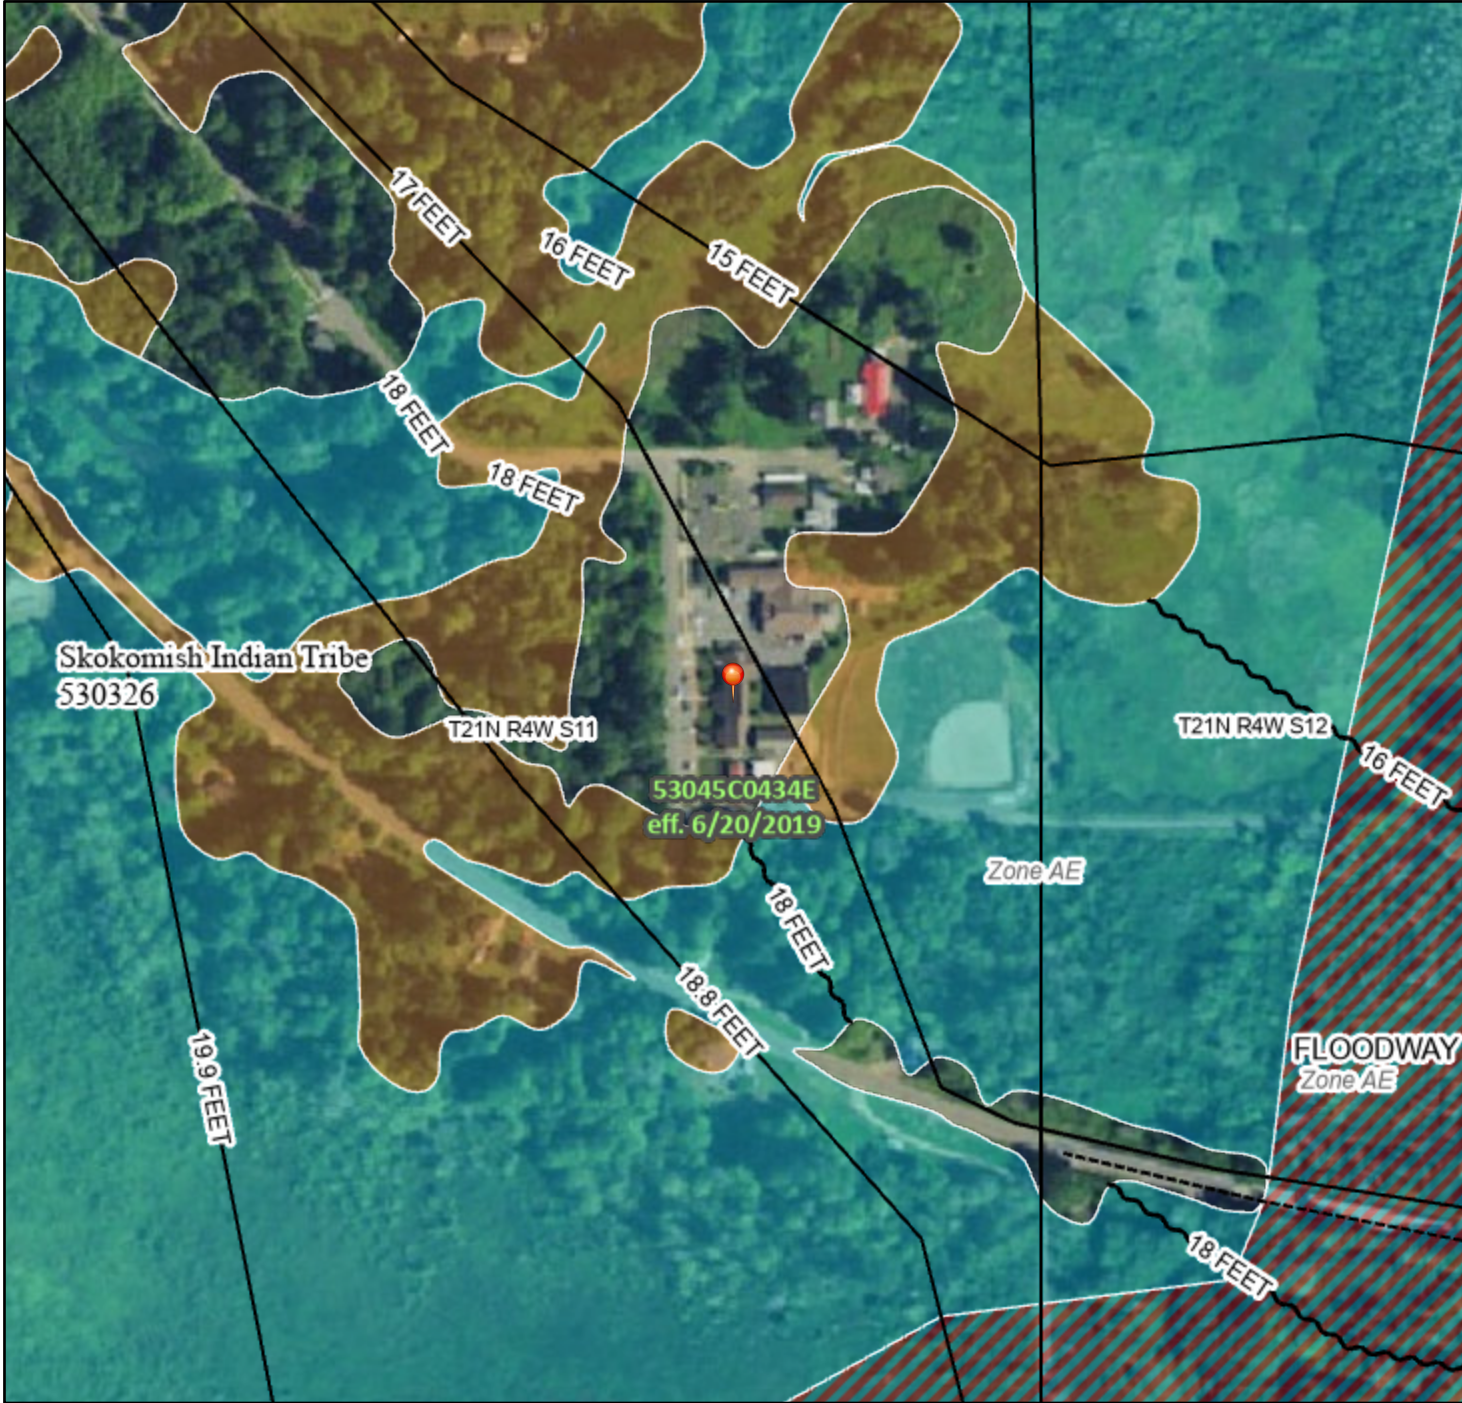
National Flood Hazard Layer FIRMMette

The site is relatively flat. The adjacent parcels are assumed to direct minimal amounts of eastbound sheet flow onto the property. The site generally slopes to the east and sheet flows across the adjacent field to the Skokomish River. The project site is located in a FEMA identified flood hazard area, according to the FEMA Map included in Appendix A-5.

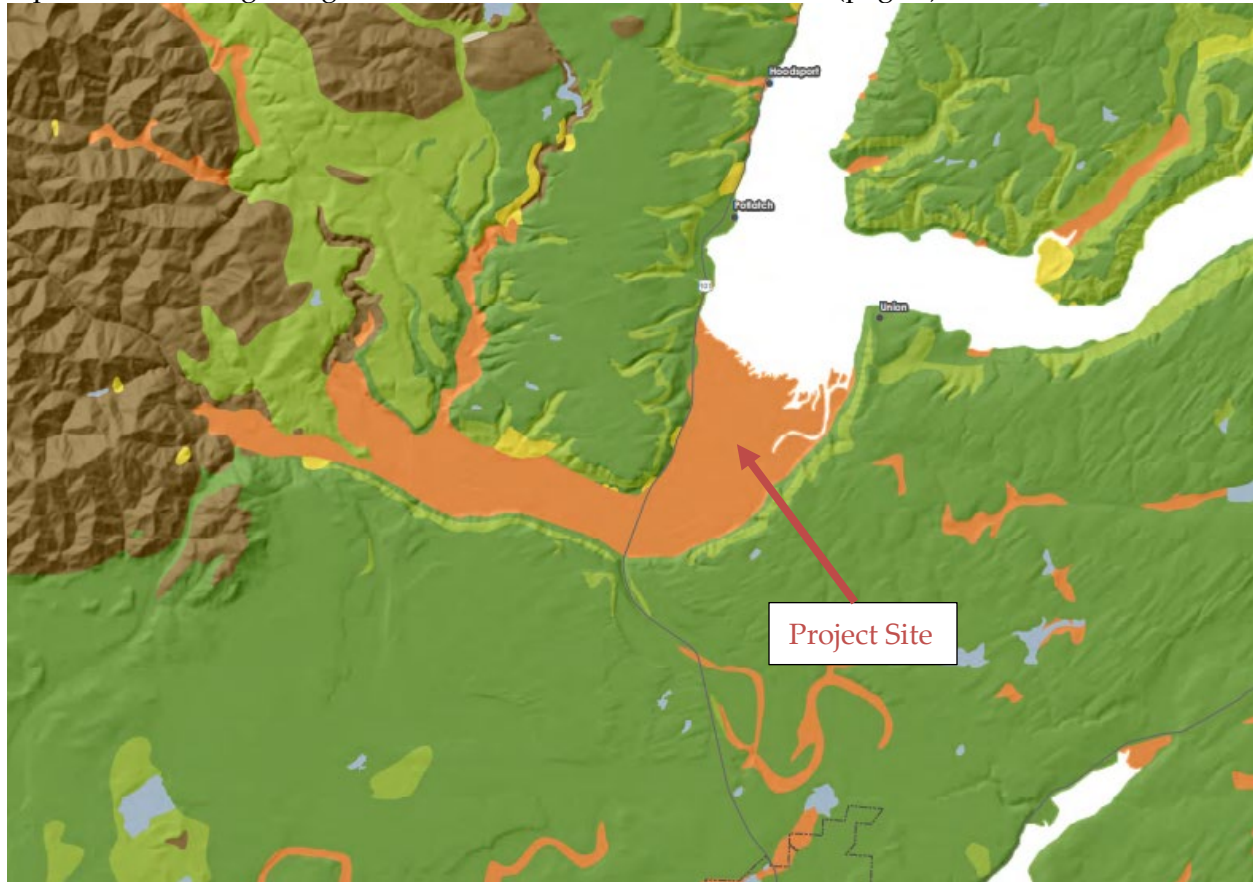
Figure 4. Excerpt from the Mason County Seismic Soils & Liquefaction Risk Map (2017)

The *Mason County Seismic Soils & Liquefaction Risk Map*, as prepared by Bridgewater Consulting, dated July 10, 2017, similarly classifies the site as having a moderate to high risk for soil liquefaction during a large-scale seismic event, as shown below (page 6).
